INDOOR AIR QUALITY REASSESSMENT

**John R. Briggs Elementary School
96 Williams Road
Ashburnham, Massachusetts**

Prepared by:
Massachusetts Department of Public Health
Bureau of Environmental Health Assessment
January, 2000

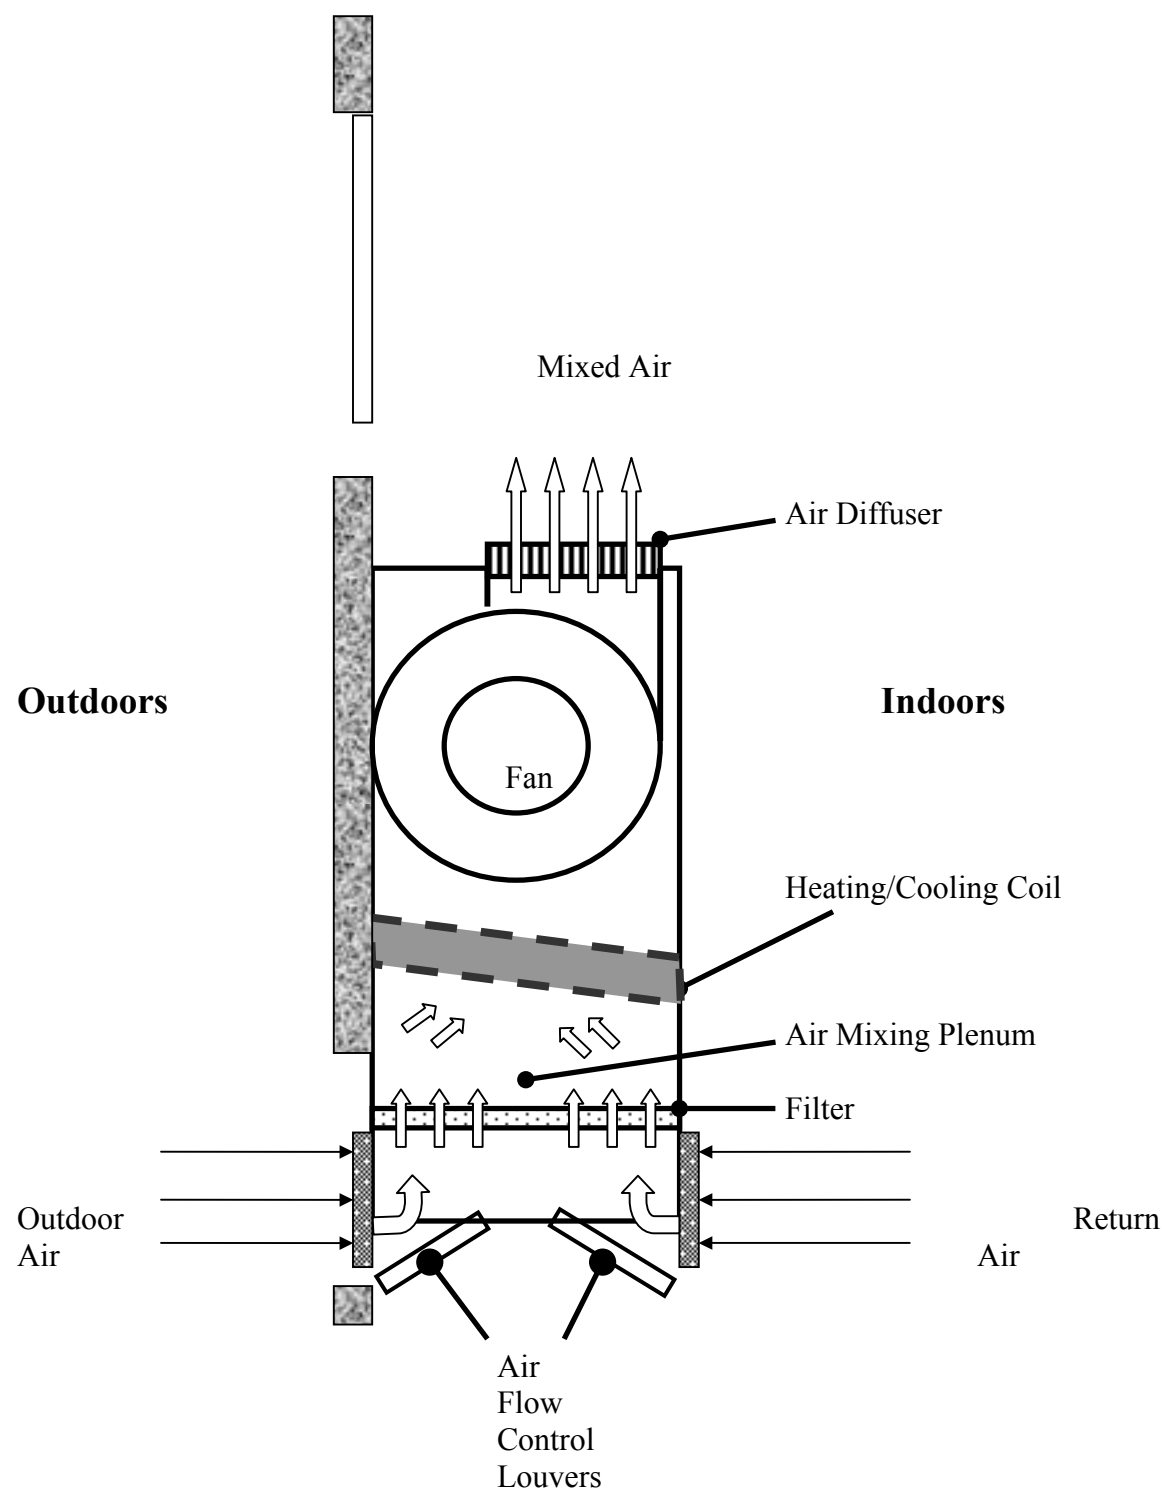
Figure 1

It can be seen from the tables that carbon dioxide levels were elevated above 800 ppm (parts per million) in 22 of 31 areas surveyed, which indicates an overall ventilation problem in this school. Fresh air in classrooms is supplied by a unit ventilator (univent) system (see Figure 1). Obstructions to airflow, such as books, papers and posters on top of univents; and bookcases, tables and desks in front of univent returns, were seen in a number of classrooms. To function as designed, univents and univent returns must remain free of obstructions. More importantly, these units must be activated and allowed to operate.

Unit Ventilator (Univent)

3. Remove materials blocking the fresh air diffusers or return vents of univents. Univents must remain clear of obstructions in order for the equipment to function properly.

4. In order to improve indoor air quality, an increase in the percentage of fresh air supply into the univent system may be necessary. Survey classrooms for univent function to ascertain if an adequate air supply exists for each room.

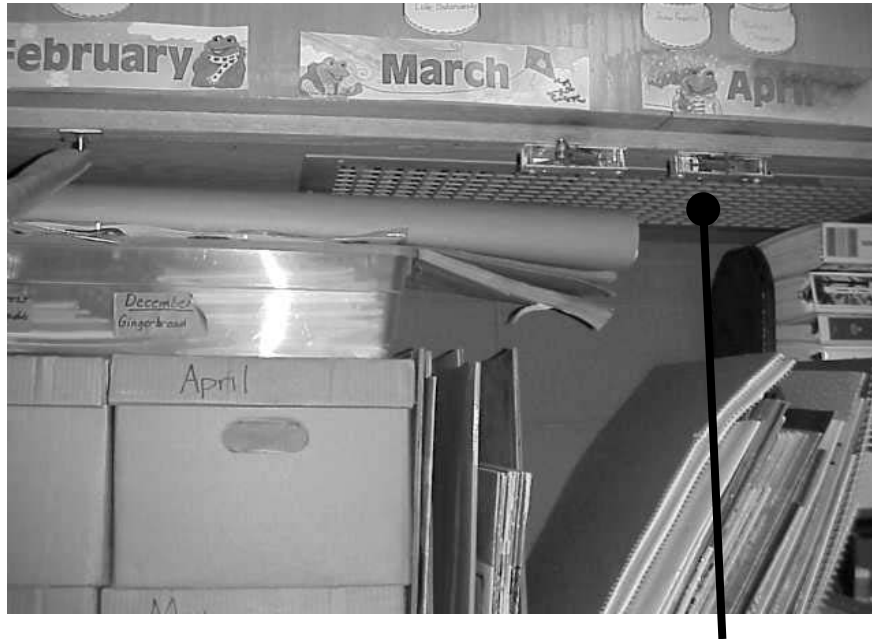
1.1. Picture 1

Exhaust ventilation in classrooms is provided by a mechanical exhaust system. The exhaust vents are located in the upper portions of coat closets in classrooms (see Picture 1). Classroom air is drawn through a space beneath the closet door (see Picture 2). This design allows for these vents to be easily blocked by stored materials on shelves beneath the exhaust vent. In a number of classrooms, these vents were blocked with books, book bags, boxes and other obstructions. The rooftop exhaust vent motors servicing the classrooms were examined (see Picture 3). All of the exhaust vent motors were found inoperable and in need of repair.

2. Exhaust Vent in the Ceiling of the Classroom Closet

7. Clear a three-foot space around all exhaust vents where feasible and reduce stored materials in classroom closets such that airflow is not impeded. Exhaust ventilation is necessary to remove pollutants from the interior of classrooms. If exhaust ventilation cannot be run continuously, adjust exhaust unit ventilator to have exhaust run as much as this equipment will allow.

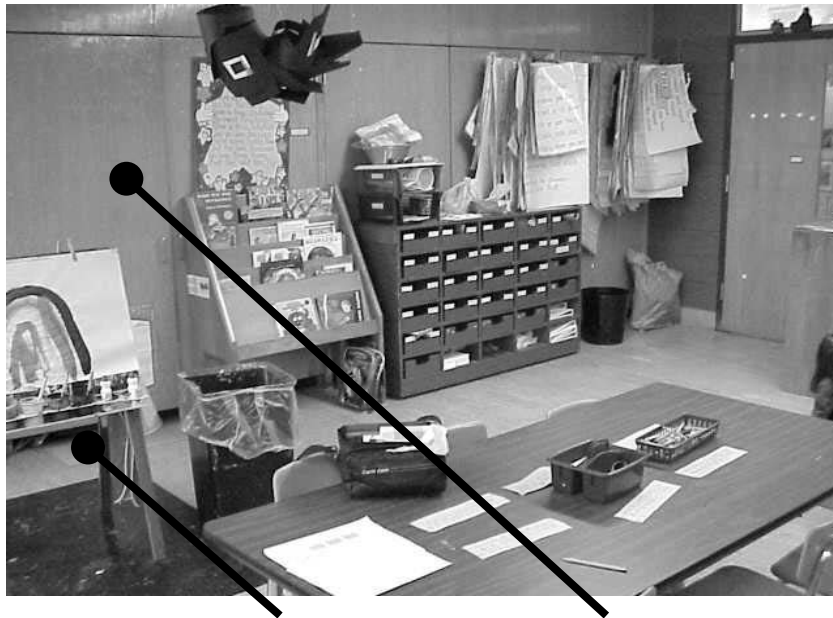
2.1. Picture 2

Exhaust Vent Located in Closet

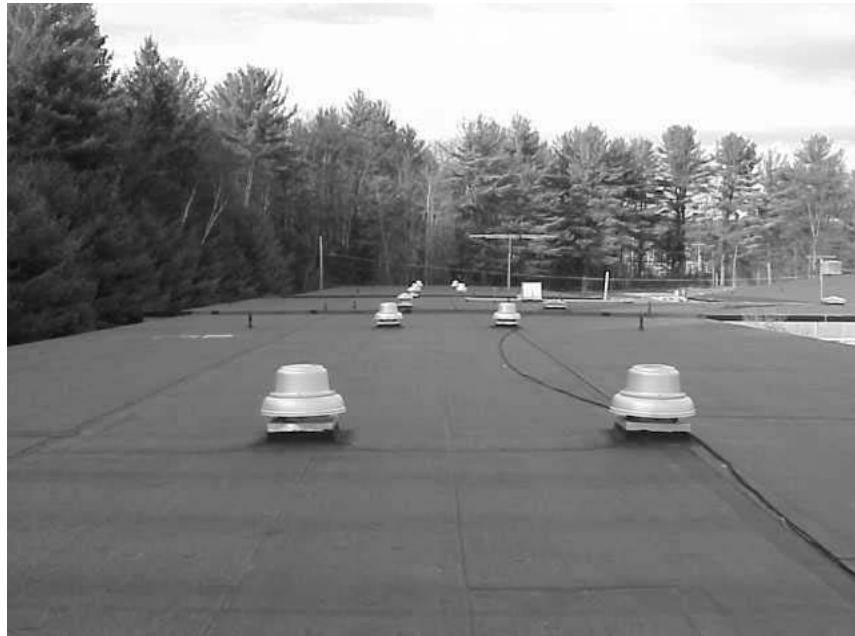
Picture 3

1. The majority of rooftop-mounted exhaust ventilation motors were either deactivated or broken. Each of the motors should be repaired and/or reactivated to provide exhaust ventilation in all classrooms.
2. The gutter system for the modular classrooms does not have downspouts to direct rainwater from the base of this structure. Downspouts should be replaced to prevent water penetration.

Inoperable Exhaust Vent Motors On Roof

5. Repair the exhaust ventilation motors.
6. Examine the feasibility of providing both fresh air supply and exhaust ventilation for the modular classrooms.

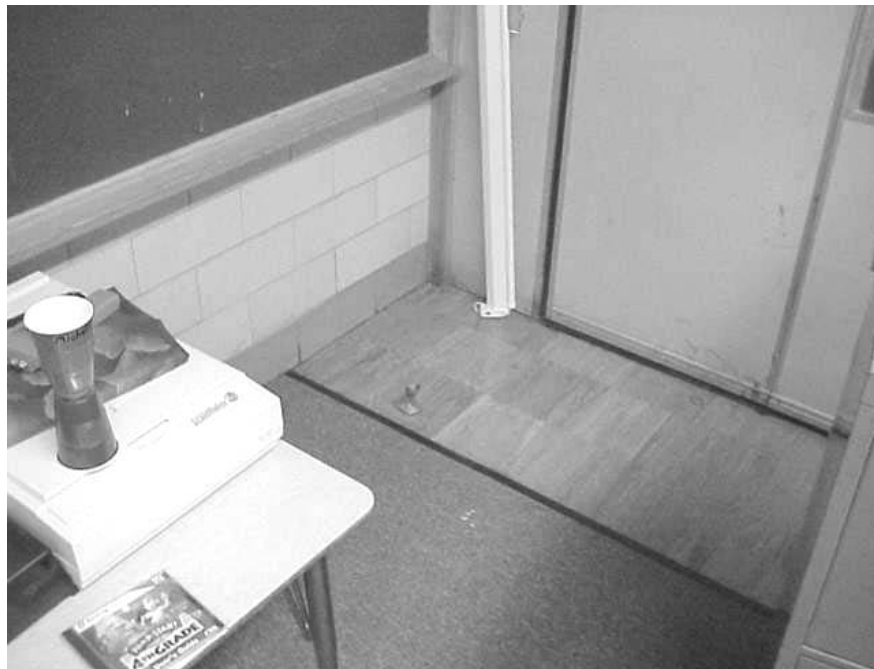
Picture 4

As indicated by school personnel, a corner of classroom 134 has experienced periodic mold odor (see Picture 4). The odor is confined to the interior wall opposite the hallway door. No obvious source of moisture exists in this corner that can be attributed to plumbing or roof leaks. No classroom materials, except for the bottom part of the file cabinet (see Picture 5), had signs of water damage. According to school officials, carpets in the classroom are wet cleaned prior to the beginning of school. The mold odor was reported to be present for the first several months of the school year and would dissipate over time. School officials reported that this corner of the carpet (roughly a 4 foot by 10 foot) square was wet cleaned two weeks prior to this assessment. Moisture sampling was done in the carpeting and under the plastic carpet runners. Most areas of carpeting had non-detectable levels of moisture, however moisture measurements beneath the plastic runner in the corner wet cleaned had moisture content measurements of 8 to 25 percent (see Picture 6). Measurable levels of moisture were also found under the plastic runner for a distance of approximately 10 feet from the interior wall (see Picture 7). With the lack of visible sources of water that would moisten carpet, the presence of measurable levels of moisture would indicate that the wet cleaning process is the probable cause of mold growth in this carpet. During late August, early September, Massachusetts is

Corner Of Classroom 134 With Reported Mold Odors

1. Follow the recommendations made in the BEHA letter dated December 23, 1999 concerning removal of the carpet from classroom 134 (MDPH, 1999) (See Appendix 1).

2. Discontinue wet cleaning of carpeting to prevent further mold growth. Evaluate carpeting in other classrooms for mold growth and consider removing carpet in a manner consistent with asbestos remediation laws and regulations.

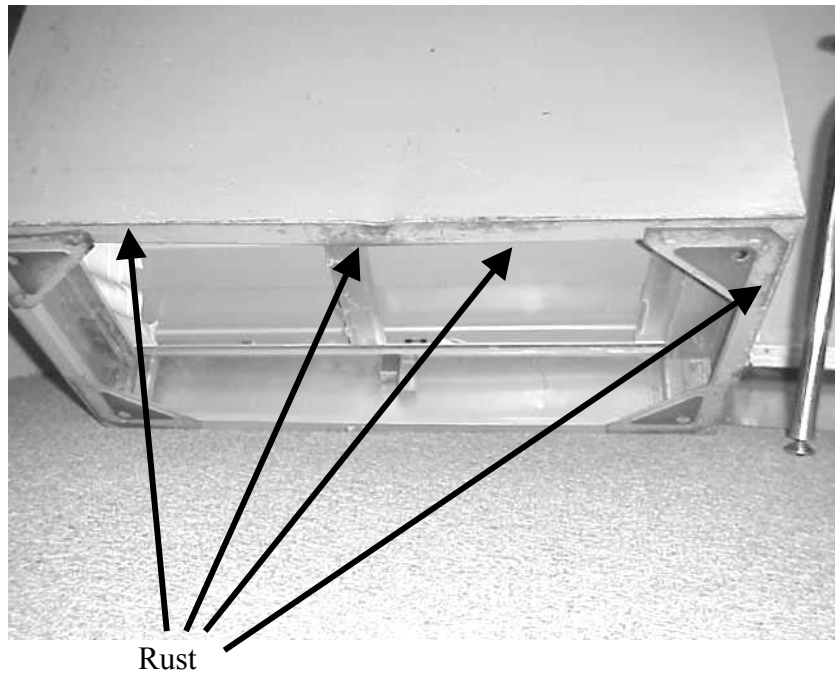
Picture 5

**File Cabinet in Room 134 Over Moistened Carpeting,
Note Rust on Underside of File Cabinet In Contact With Carpet**

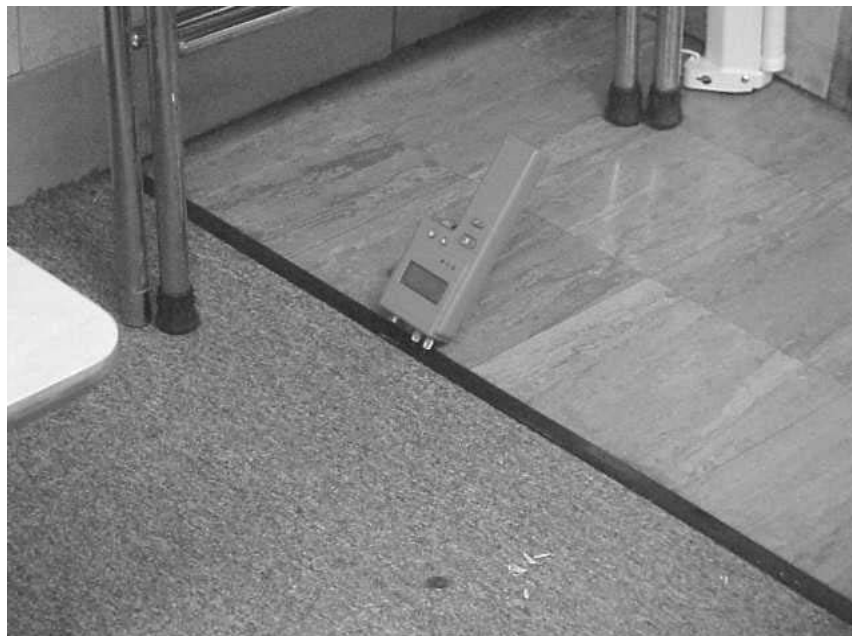
Picture 6

The carpet runner was found lifted from the floor surface. It appears that as the carpeting was cleaned, water from this process was injected underneath the carpet runner. Since the carpet runner is water impermeable, this moisture cannot evaporate as rapidly as exposed carpet. Finding measurable levels of moisture beneath the carpet runner with no measurable moisture levels in most areas of the carpet two weeks after wet cleaning would confirm this theory. In addition, the length of carpet runner with measurable water contents roughly corresponds to the area of carpet cleaned two weeks prior to the assessment.

During the November 5th assessment, we analyzed the moisture content of the carpet two-weeks after it was cleaned with a water-based method. While no moisture was measured in the carpet, detectable concentrations of moisture (8 percent to 25 percent) were measured under the plastic runner at the edge of the carpet. It appears that the water-based carpet cleaning method utilized injected water underneath the plastic runner. Since the plastic runner is water impermeable, the water is trapped and cannot evaporate as rapidly as the rest of the carpet. This results in the carpet remaining moist and can serve as a means for mold growth. Once a carpet has become colonized with mold, wet cleaning methods are likely to result in enhancing mold growth shortly after the application of water. In this case, removal of the carpet along this plastic runner that was wet cleaned (roughly a 10 feet by 4 feet section at a minimum) is recommended.

**Moisture Meter Reading Water Content of the Space beneath the
Plastic Carpet Runner**

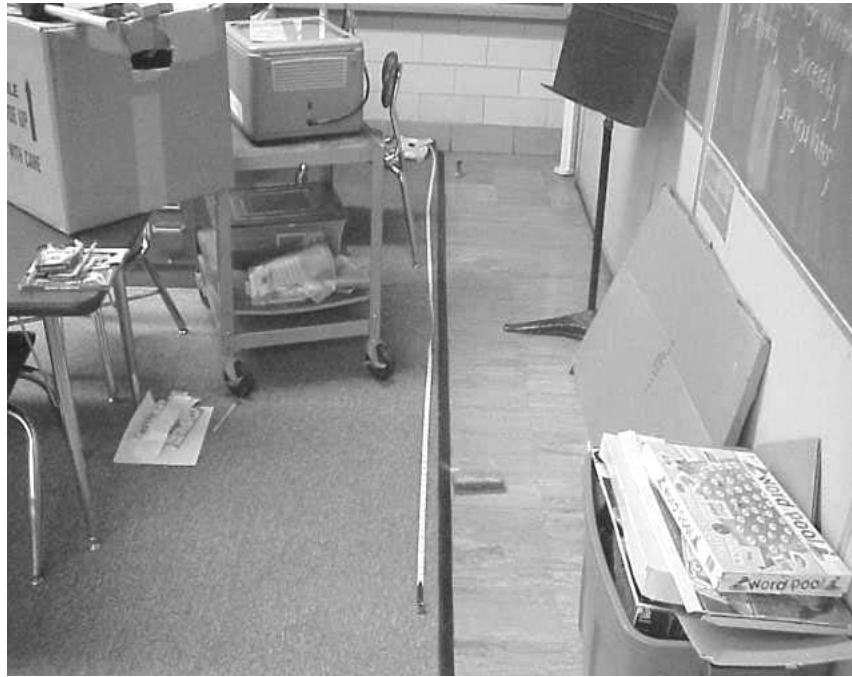
Picture 7

**Length of Carpet Runner with Measurable Levels
Of Moisture (Approximately 10 Feet)**

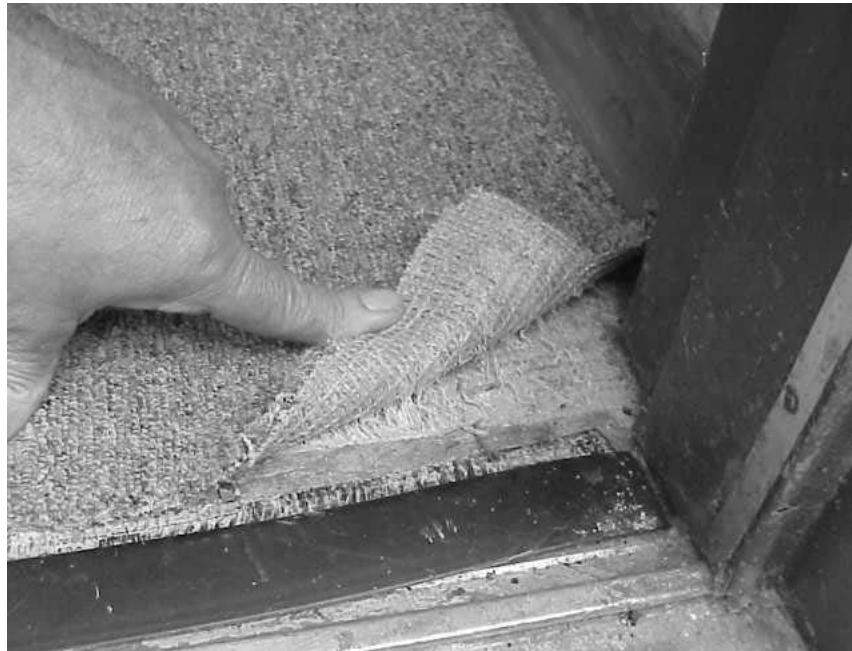
Picture 8

It was discovered that the carpet installed in classroom 134 appears to be backed with a natural material, possibly jute (see Picture 8). Natural materials, like jute, can be susceptible to mold growth if carpeting is allowed to remain moist. If mold has colonized carpeting, the addition of moisture can result in increased mold growth.

Jute-Backed Carpeting in Classroom 134

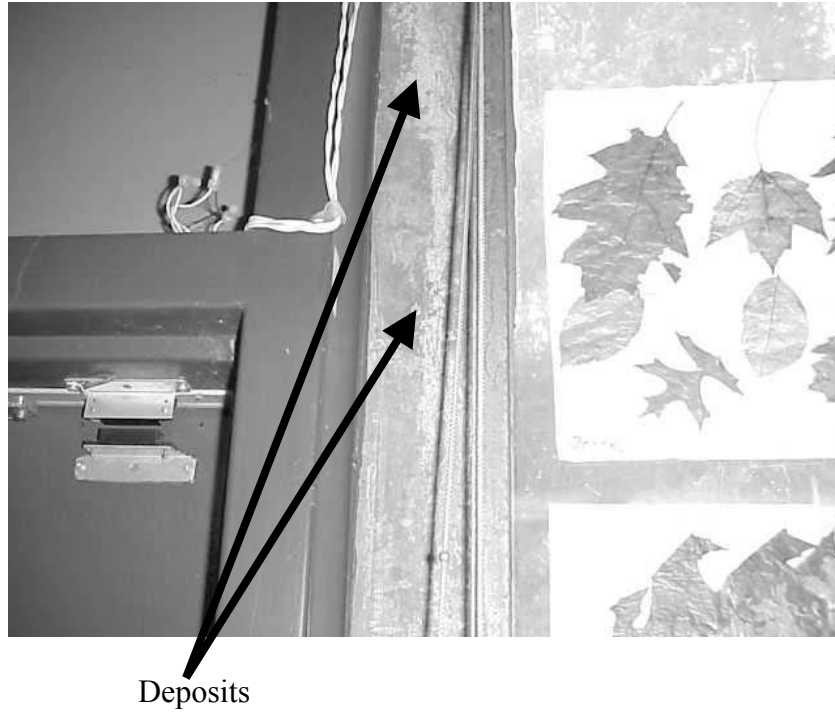
Picture 9

The school also appears to have water penetration through window frames as noted by signs of water damage (see Picture 9). In the guidance office, tiling on the windowsill has curled due to water damage (see Picture 10). Water penetration through window frames can serve as a mold growth medium.

Dried Water Deposits in Interior of Classroom Window Frames

12. Examine windows for water penetration and repair where needed. Remove/replace water damaged wood and tiling. Examine areas underneath water damaged materials for mold growth. Disinfect these areas with an appropriate antimicrobial.

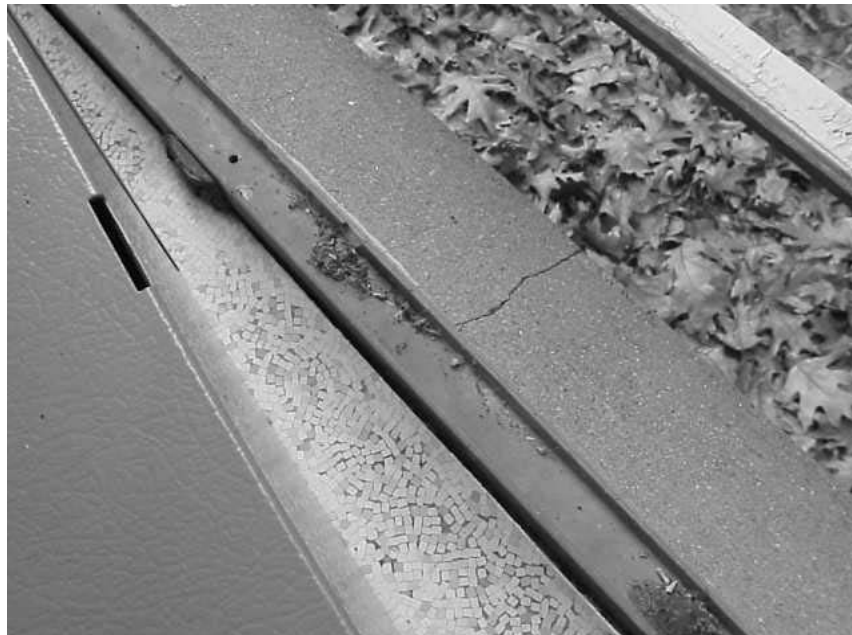
Picture 10

Curling Tile on Window Sill

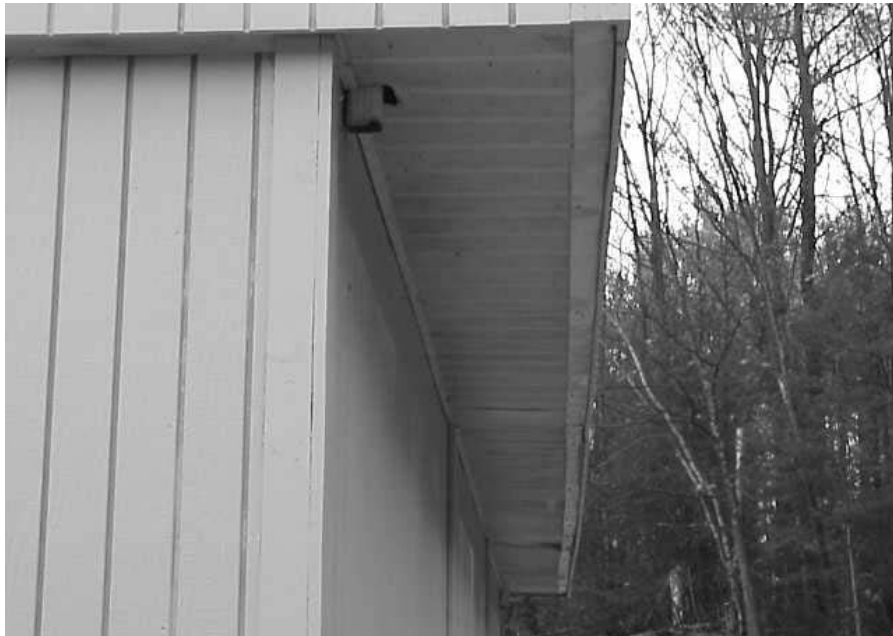
Picture 11

The roof of the portable classrooms is outfitted with a drainage system that is connected to downspouts. Downspouts for this system are not connected to the roof system (see Picture 11), which allows rainwater to impact on the ground below and chronically wet the exterior wall. Downspouts should be designed to direct rainwater away from the base of the portable classroom exterior walls to prevent rainwater from penetrating through the asphalt/exterior wall seam into the classroom crawl space. The wetting of exterior walls and crawlspace soil can result in mold growth.

Gutters Missing Downspouts on Modular Classrooms

15. Reconnect the portable classroom downspouts to the roof drains. Examine the feasibility of directing downspout water away from the base of the portable classroom's exterior wall.

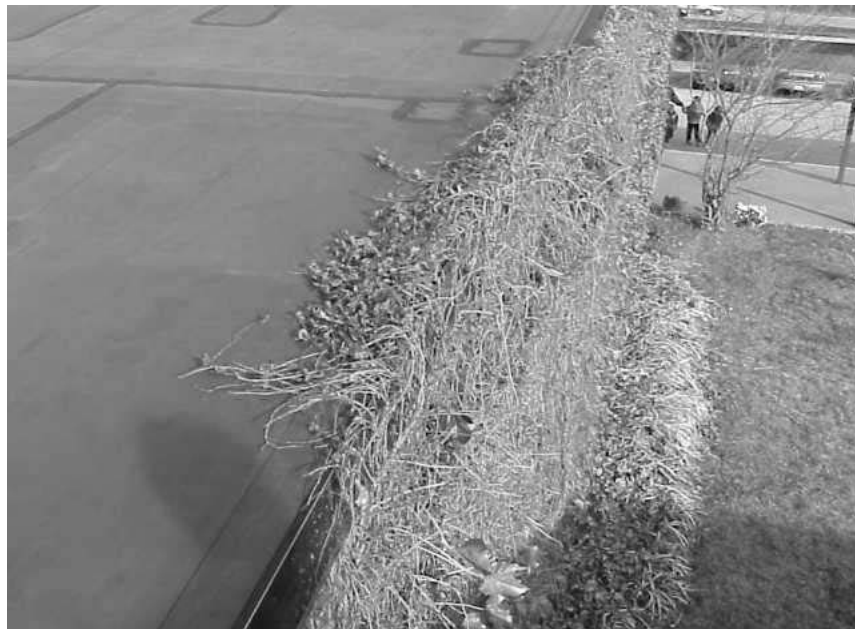
Picture 12

The front courtyard of the school has a wall that has a substantial ivy growth (see Picture 12). The interior wall of the ivy growth was free of signs of water penetration. Clinging plants can cause water damage to brickwork by inserting tendrils into brick and mortar. Water can penetrate into the brick along the tendrils, which can subsequently freeze and thaw during the winter. This freezing/thawing action can weaken bricks and

mortar, resulting in damage to this wall. In order to avoid this problem, clinging plants on brickwork is not recommended.

Ivy Growing on the Exterior of the J. R. Briggs Elementary School

17. Consider removing clinging vines from the exterior of the building.
18. Remove the springs from the teacher's rest room doors and adjust the passive vent louvers to provide an adequate supply of transfer air.
